Wilson Ranch Community  
Community Wildfire Risk Assessment  
2020 Update

Updated by:  
Mindy Untalan, Conservation Planner

*The formal assessment update visit was conducted on May 27, 2020 by Mindy Untalan.*

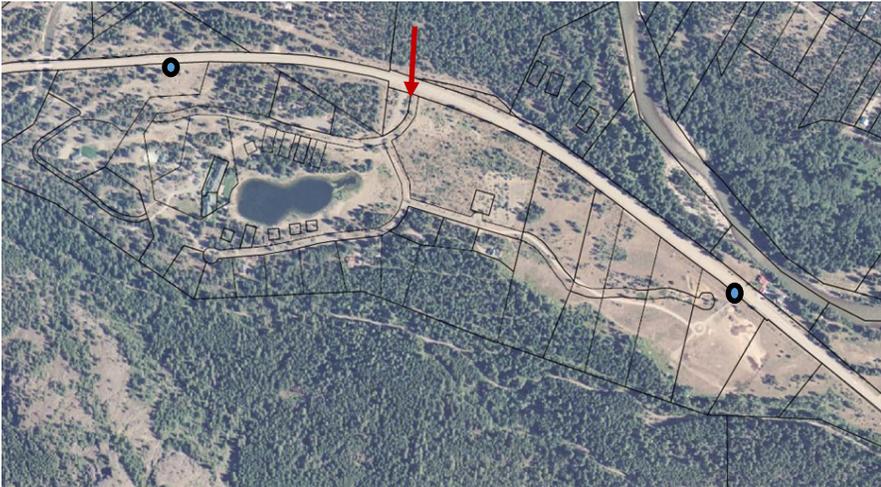
*Map of HOA. Red arrow is identifying main entrance. Blue points are location of emergency exits.*

*Recommendations-* Adding emergency exit signs on the main drive pointing in the direction of a emergency exit and notify guests and temporary renters of the two exits in case of emergency.

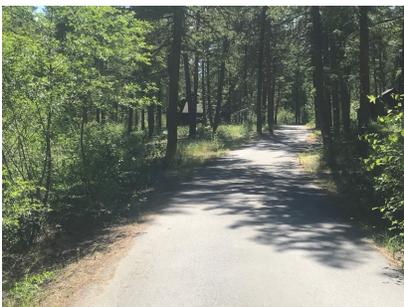
*Road near Freestone cabin.*

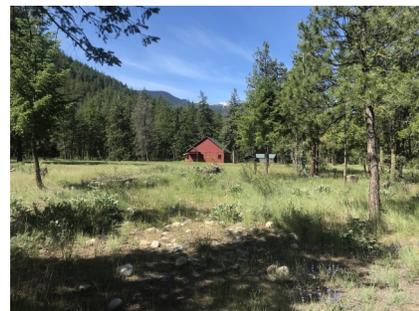
*Open space near Freestone Inn*

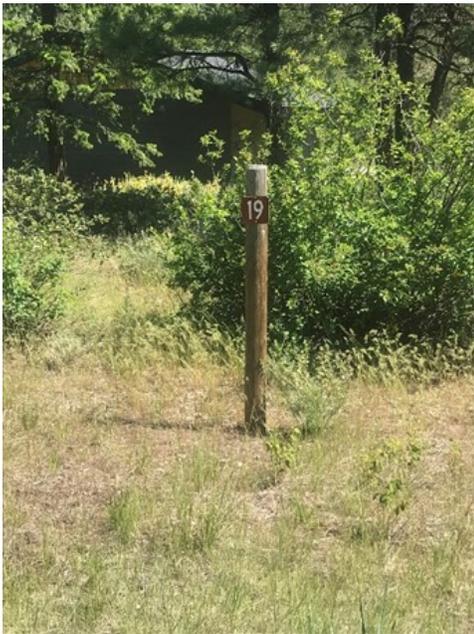
*Reflective address sign Elsie Meadow.*

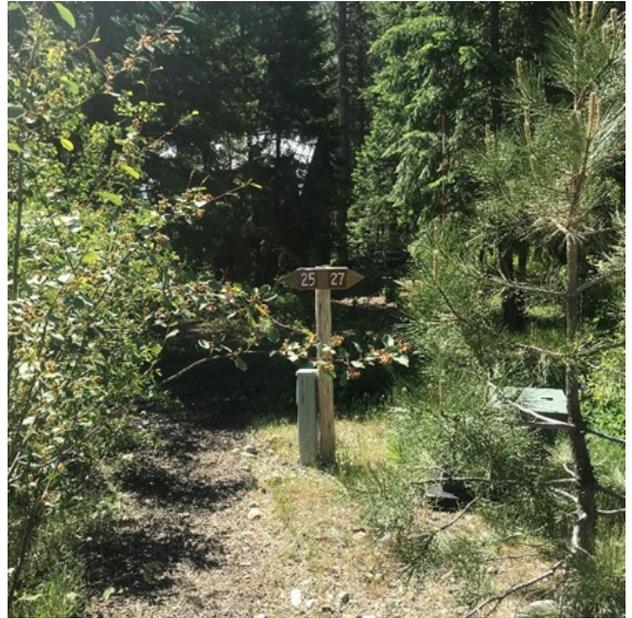
*Reflective address signs Lake lots.*

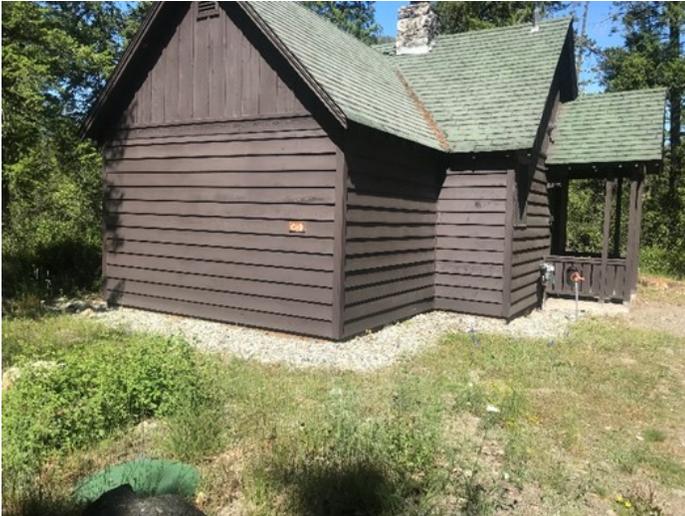
*Wood address sign Freestone cabins.*

*Recommendations-* Recommend adding reflective address signs to the cabins as well. Also adding reflective street signs identifying emergency exists as well.

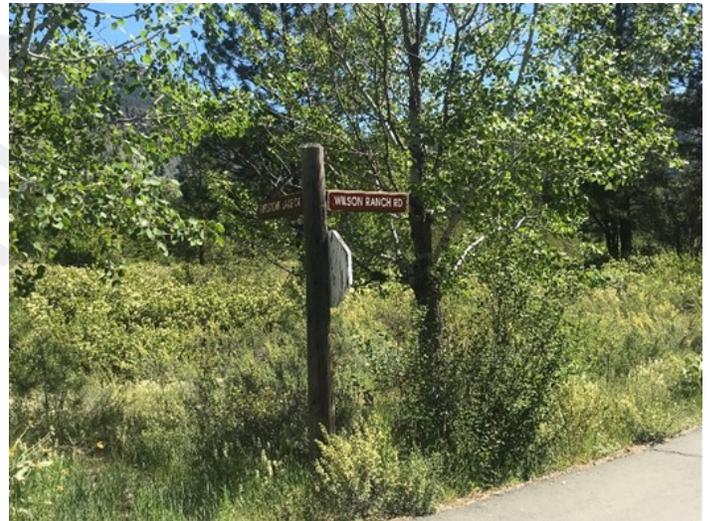
*Reflective street signs in community.*

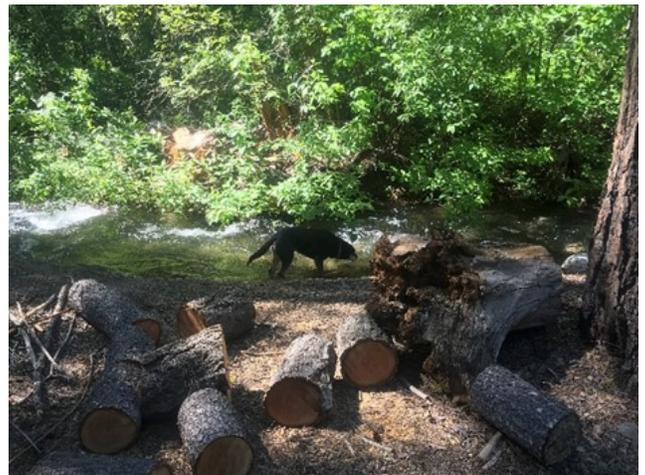
*Irrigation ditch behind cabins.*

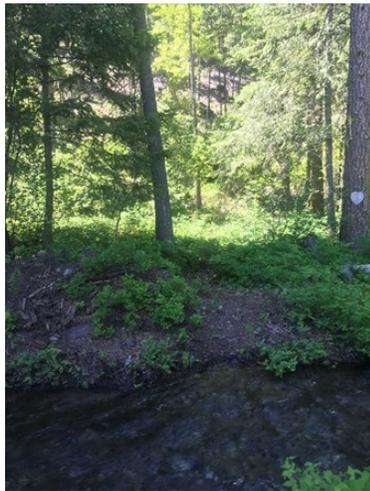
*USFS property near community.*

The community borders United States Forest Service (USFS) land. *USFS did forest thinning recently near community. USFS has reduced some fuel loads but a large amount of slash is on the ground. After thinning there has been improvements but still a concern for fire spread.*

*Recommendations-Improvements have been made since the 2014 community assessment. The community cannot take action on neighboring USFS property. Recommend continue to create defensible space on residents own property by pruning trees and removing understory from the base of trees. Remove branches hanging over or touching structures and propane tanks. General recommendation is 5ft of nonflammable perimeter around structure and propane tanks. 5-30 ft well maintained lawn with grass cut low and vegetation pruned back. 30-100 ft fuels reduction and thinning trees so they are spaced 20 ft apart, pruning and brush removal. These actions will reduce the intensity of wildfires and significantly reduce the risk to the community. The Community has yearly spring clean up days for residents to participate in. Continue to encourage residents to take part in the event.*

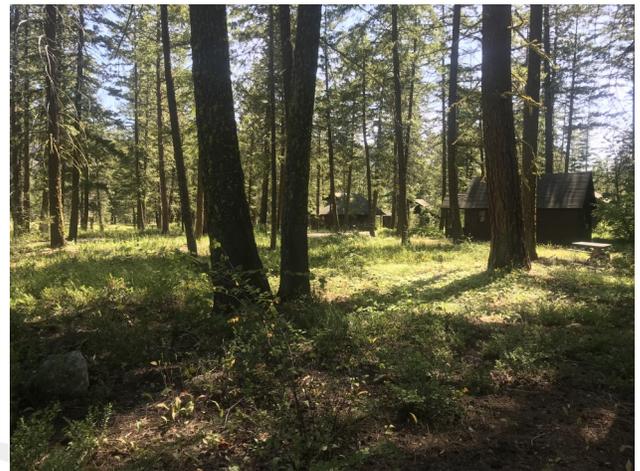
*Thinning work done HOA open space.*

*Recommend thinning more of the open spaces within the community. It was noted that some of the open spaces have had fuel reduction work done but needs to continue through the rest of the areas.*

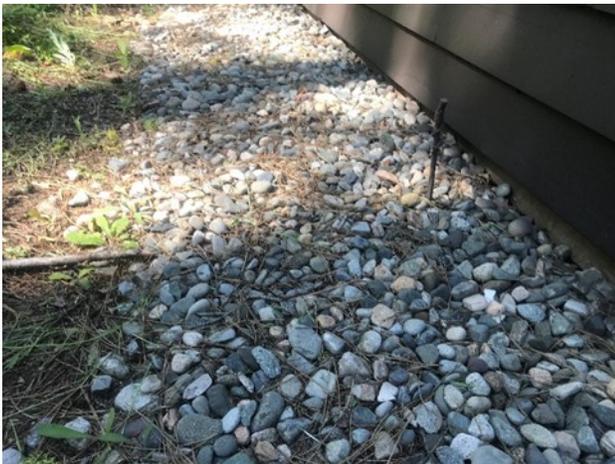
*Pine needles on gravel perimeter around cabin*

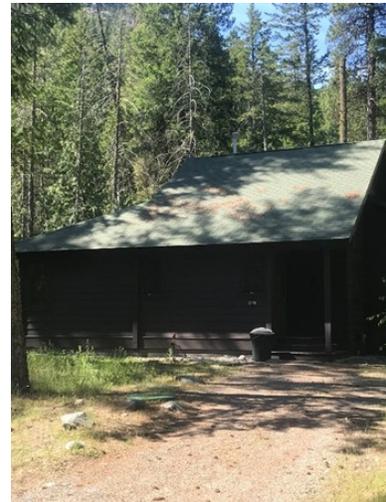
*Pine needles on cabin roof*

*Observations* - The majority of roofing materials are metal or composition shingle within this community which has not changed since the last community assessment. *Notice pine needle build up on several of the roofs with in the community.*

*Recommendations* - Continue to use non-combustible roofing material. Residents need to continue to keep roofs and gutters clean.

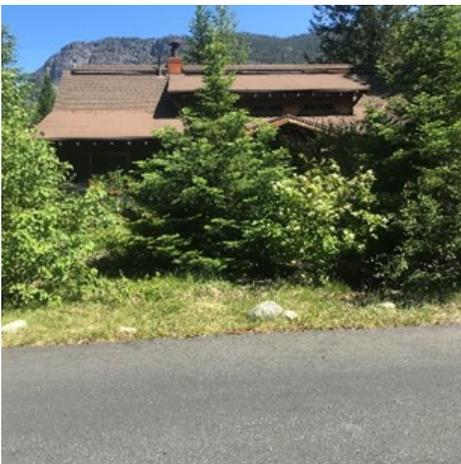
*Home with over hanging vegetation.*

- *Privacy vegetation should be trimmed back so it is not over hanging structures or the road ways. Remove leaf litter around the base of the plants.*

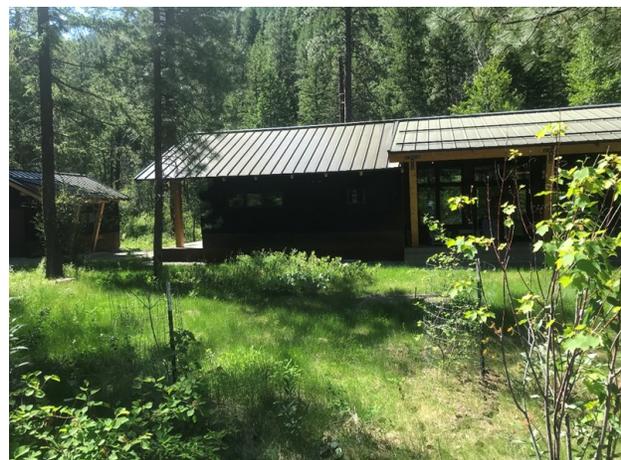
*Home with defensible space.*

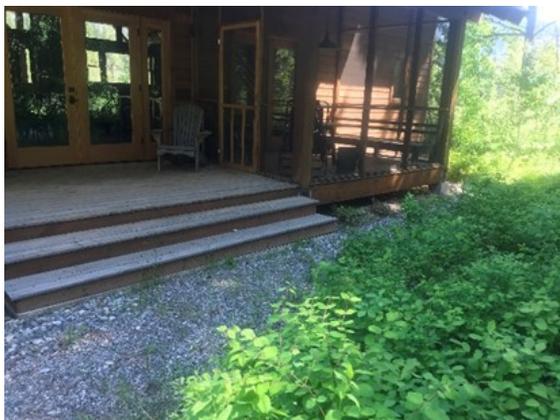
*Home with non flammable perimeter but over grown vegetation.*

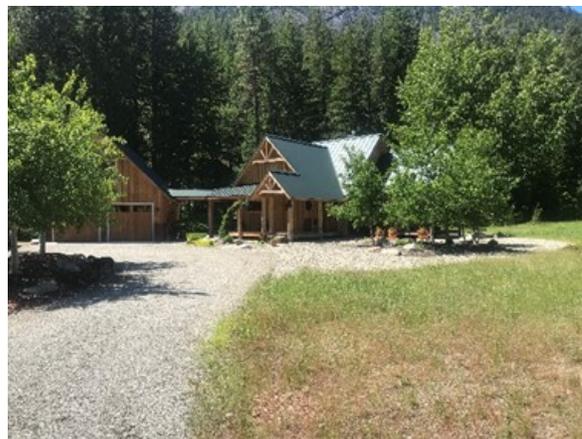
*Home with non flammable perimeter and grass cut low.*
